Rebedding Pulpit

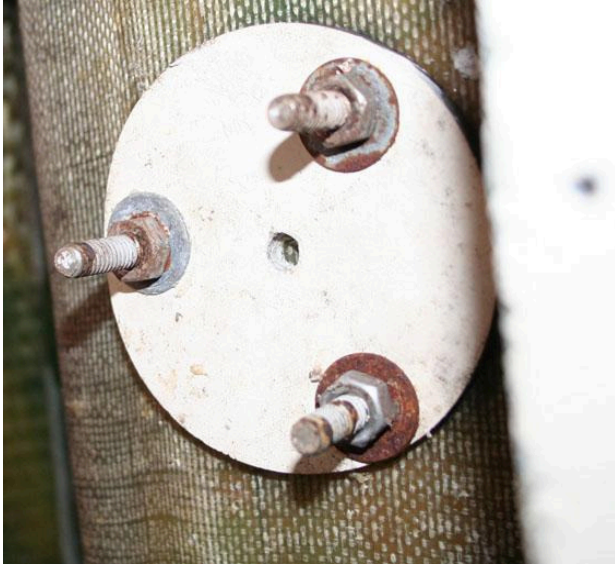
This is a view of the underside of one of one of the pulpit legs. As you can see from the stains and rust that some water has been entering around the bolts.

The upper left gasket was removed from the above pulpit foot. As you can see water and dirt that had migrated between the pulpit foot and gasket. Most likely this was ONE of the sources of my water leak... But not the only one. I went local hardware store and purchased several \$0.99 sheets of rubber gasket material.

I then placed the gasket under the foot and traced it with a sharpie. Next very small holes were drilled for the new bolts to pass through.

This repeated four times and new stainless steel screws, washers, and nuts are installed and tightened...
