# SERVICE BULLETIN

BULLETIN NUMBER: 10

MODEL: Westerbeke 40 and WPDS 10-15

SUBJECT: Sea Water Pump Clearance and Alignment

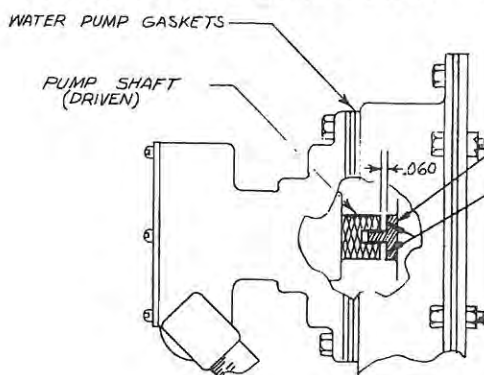
Adequate longitudinal clearance between the sea water pump shaft and the driving shaft is established by the use of multiple pump gaskets. The number of gaskets required can vary from 1 to 4. Enough gaskets must be used so that the shaft ends do not mate. See figure 1.

The application of liquid or paste type Prussian blue (at points indicated by arrows) will give positive indications of pump drive contact which will require the use of additional gaskets.

If the proper clearance is not maintained, the sea water pump shaft will force the fuel pump drive hub against its bushing. The bushing will seize to the drive hub and rotate in its housing. Bushing wear and loss of oil pressure will result.

When replacing the sea water pump be sure that the same number of gaskets is replaced and there is the required clearance.
