AFT SLING PLACEMENT ON THE PEARSON 36 CUTTER

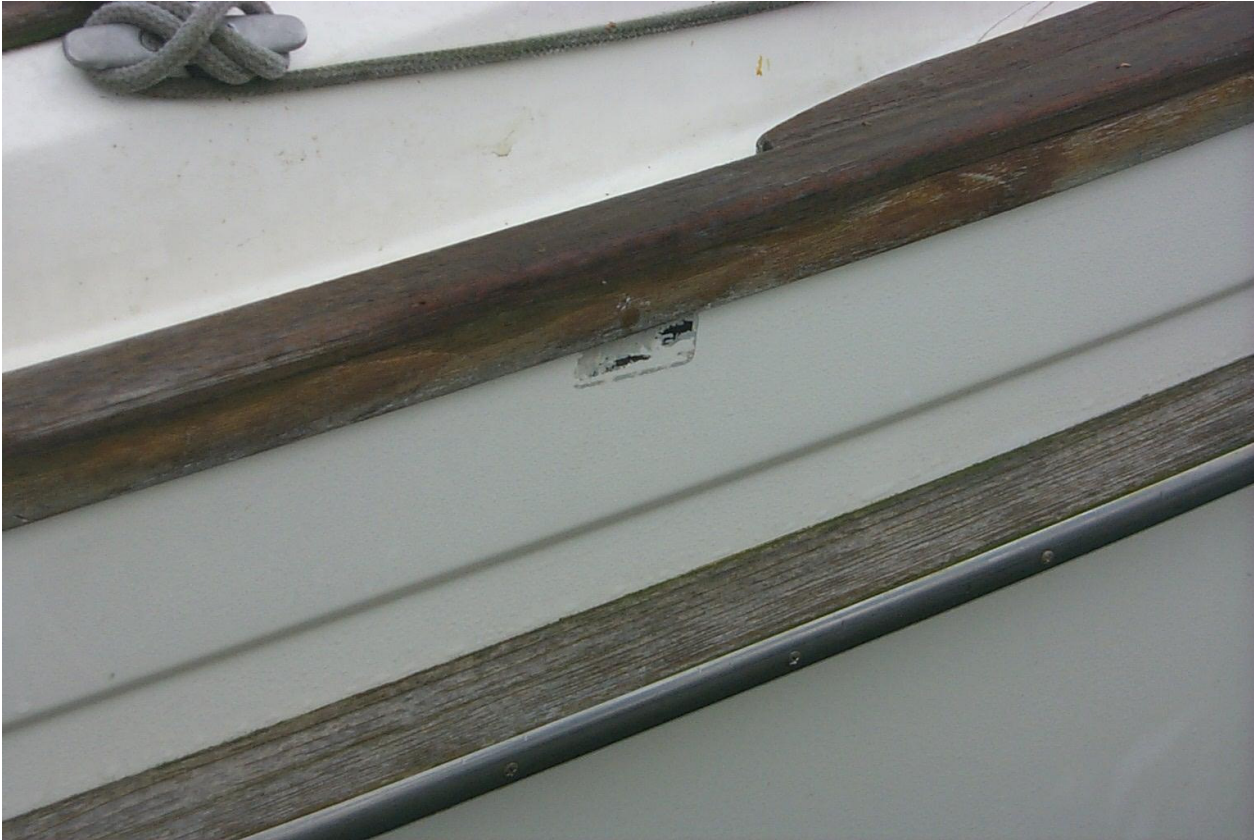
In the center of the picture you can see the worn and faded sticker marking the lift point on the Starboard side.

The old stickers have since been replaced with a new weather proof "LIFT" labels.

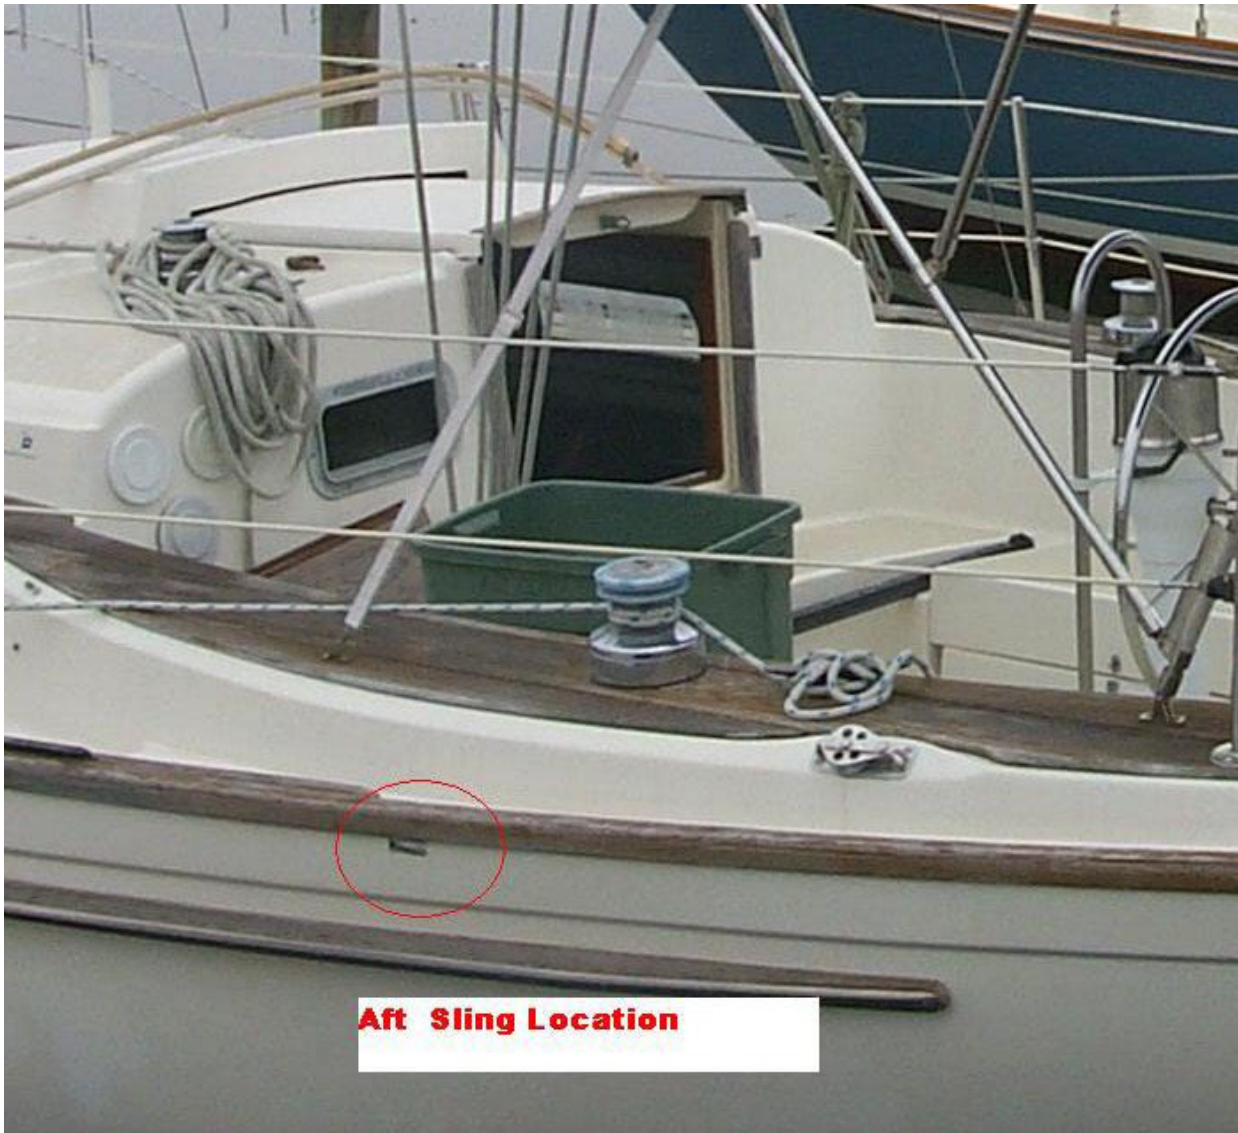
Aft Sling Location

Zooming out you can see the location of the lifting point marker.

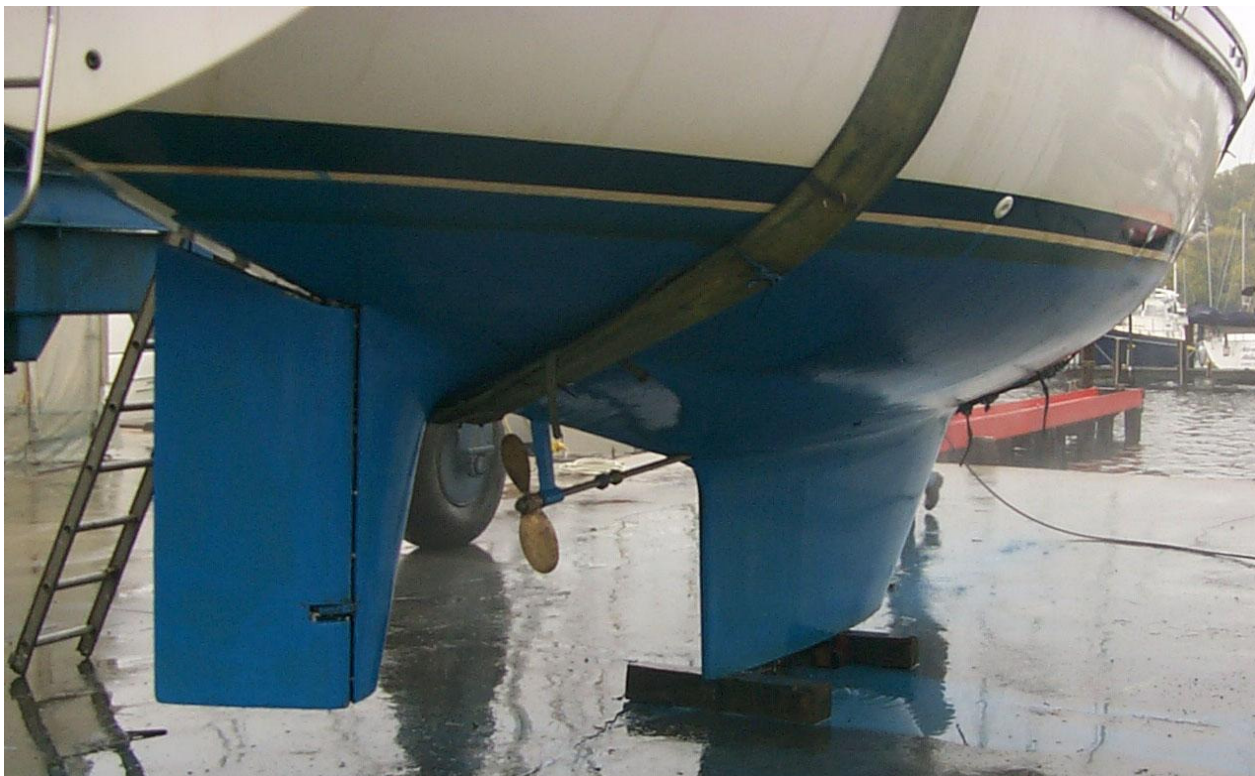
The sling in place.

Note:The limited space between the rudder skag and the propeller and shaft.
