Replacing the Ports

REPLACING 30 YEAR OLD BECKSON PORTS WITH NEW FOUND METALS STAINLESS STEEL PORTS AND REBUILDING THE FIXED PORTS

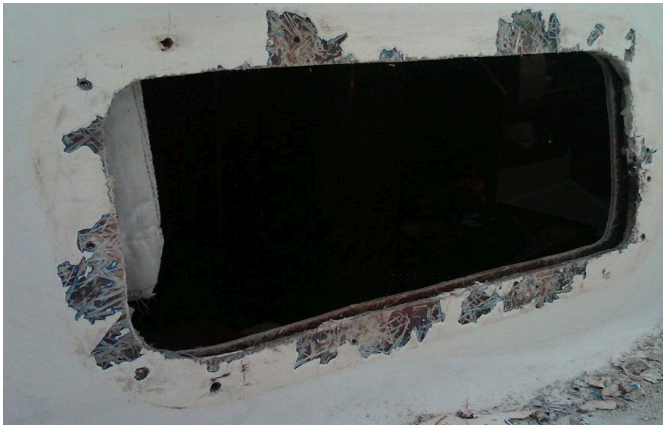
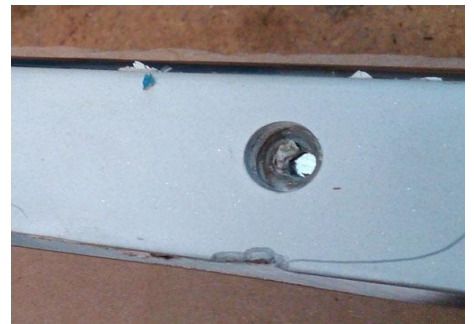
The original ports were Beckson Plastic ports which leaked at the time of the survey and purchase. The ports leaked so badly at the time of purchase that I paid the local yard to remove and bed them before we took possession of Sea Dragon. Unknown to me they decided to bed them with 5200

I tried everything to remove the trim rings without damaging the gelcoat to no avail. I tried a cold sharp putty knife and a dull blade. I tried heating the blade with a heat gun. I tried going slow and fast. No matter what I tried the 5200 was NOT going to be removed without damaging the coach roof.

Once the old ports were out I was able compare the old plastic trim rings and I was relieved to see that the NFM stainless steel trim rings are larger than the Beckson trim rings. As it turns out the new stainless steel trim rings cover all of the damaged gelcoat.

After removing the ports, I removed the remaining 5200 and older sealant using a razor blade and a lot of elbow grease.

I will soak the damaged & exposed fiberglass with epoxy resin to seal the damaged fiberglass.

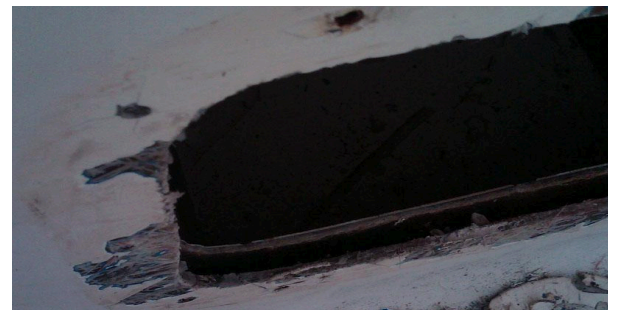
One of the reasons the ports leaked was the large space between coach roof (outer skin) and the liner. The space allowed the liner and coach roof to move breaking the thin seal between the trim ring, the port itself, and the coach roof.

After removing the ports it was clear where water was entering the port. As you can see on this port the water came in behind the trim ring, then ran down until it found its way past the seal between the coach roof, to the face of the port, and finally out between the liner.

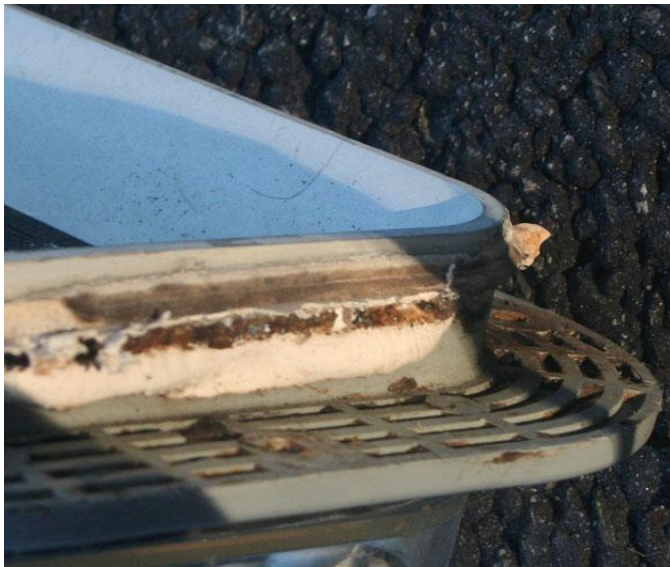
Once the ports were removed I was surprised to see how large the gap is between the coach roof and the liner. It was important to come up with a way to fill the gap. The picture on the right shows the gap on the port side of the boat. On Sea Dragon the gap is larger on the starboard side than on the port side.

As you can see the gap is a full $\frac{3}{8}$ of an inch wide on the port side. The liner is $\frac{1}{8}$ of an inch thick and the coach roof is $\frac{1}{4}$ of an inch thick.

A point of interest - at about 2 inch below the opening the liner curves out board causing the gap to shrink. The gap is widest at the opening and narrows.

The gap on the starboard side is a full $\frac{1}{16}$ of an inch wider than the gap on port side or a full $\frac{7}{16}$ inch gap.

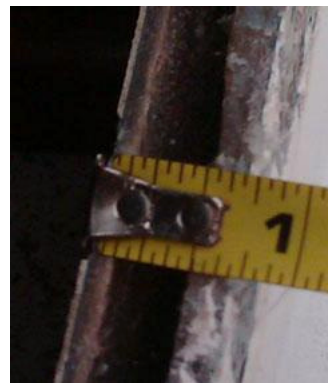
I spent some time considering my options for filling the gap and finally decided to order a piece of $\frac{3}{8}$ inch fiberglass from McMaster to fill the the bottom gap. The sides and top would be filled with $\frac{3}{8}$ strips cut from a piece of mahogany I had. My logic was that any water that made its way in would run down and be trapped on the lower filler and sit there for some time. The fiberglass will not rot like wood if it is exposed to standing water.

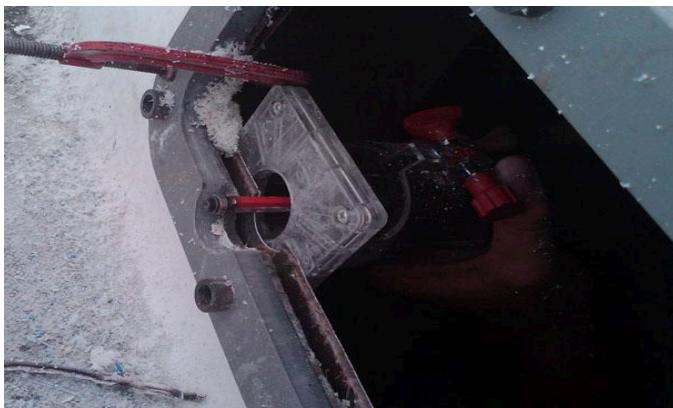
Now for the part I dislike most about any boat project, cutting the boat. At this point it is nice to have a helping hand. I was another Pearson 365 who was willing to help. Using a small router trim bit and the NFM template it was easy to enlarge the exist to match the new ports.

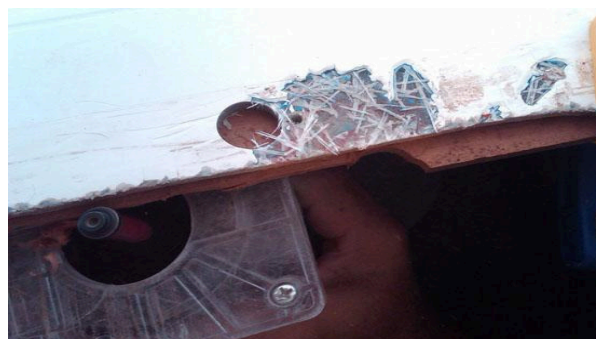
Next the upper gap was filled with $\frac{3}{8}$ inch pieces of mahogany which is trimmed and drilled before being glassed in to place.

Once the filler is expoxied into place, the fiberglass can be sanded to a smooth finish

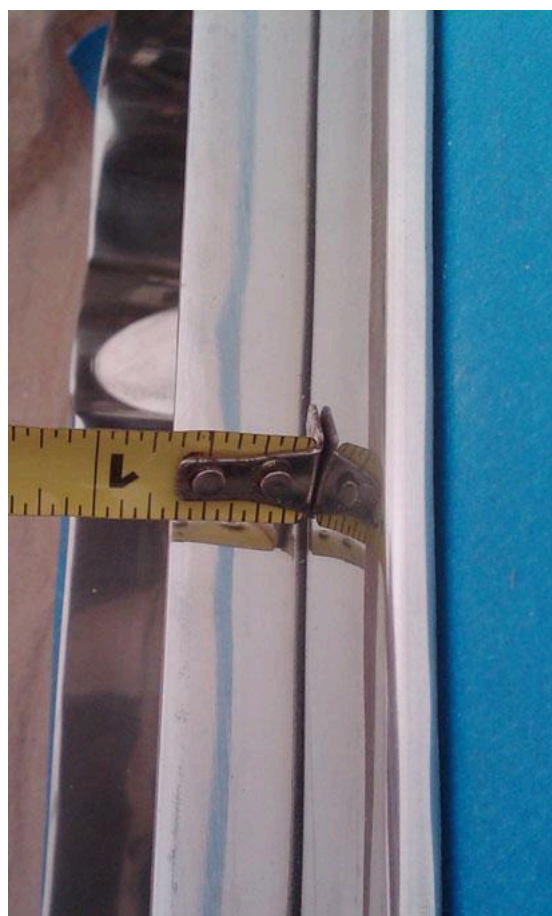
I had purchased and finished four (4) teak spacer/trim rings thinking that they would be needed. However, after removing the existing ports, seeing the gap, and doing a little math, I decided that installing the 5/8 inch thick trim rings/spacers would shorten the over hang (exposed spigot) too much for me. I wanted at least an 1/2 of inch of the actual port spigot to extend past the outer SS ring for both functionality (proper drip rail) and appearance. **Quick Math:** $1/8$ (liner) + $3/8$ (gap) + $2/8$ (coach roof) = $3/4$ plus the $1/8$ " for the Stainless Steel trim ring, I was looking at $7/8 + 5/8 = 1\ 1/2$ "

As you can see from each of the pictures of the port side portlights during their "dry fit" process I have exactly 5/8" of the spigot extending past the exterior ring. Perfect!

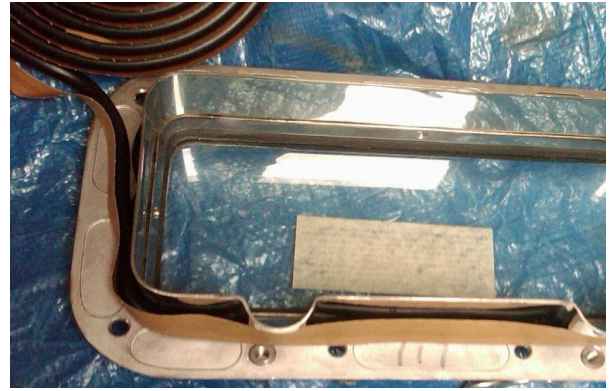
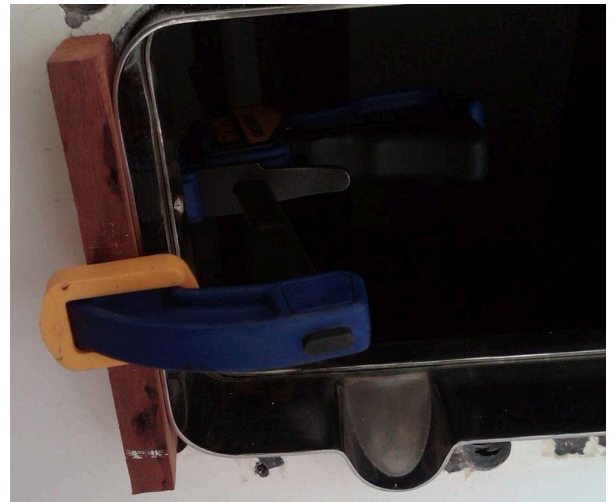
Completely compressing the butyl caulk took about 30 minutes per port. I began by tightening the screws until there was resistance. I let them port sit for 5-10 minutes while prepped the next port for installation. I would then return to the port and tighten each screw approximately one-half of a turn in a criss-cross pattern working my way from the outside edge working my way to the center.

Next I put a little anti-seize/lubricant on the screws before aligning the port and trim ring.

I wanted to have as little friction as possible while tightening the screws, also I want to protect the threads during this process.

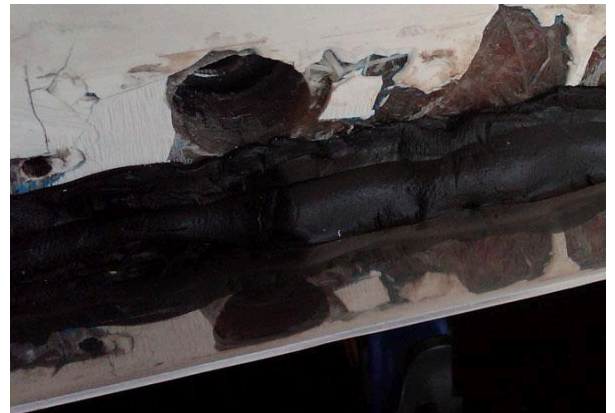
Once I felt the ports were well seated, I removed the screws & trim ring and filled in any gap in the butyl rubber caulk... Finally, following the NFM instructions applied a Boatlife polysulfide sealant. I know - some would suggest 5200... Not me see FRAME 1. **NOTE** I failed to take pictures of this process so I borrowed this picture from the NFM very nice website...

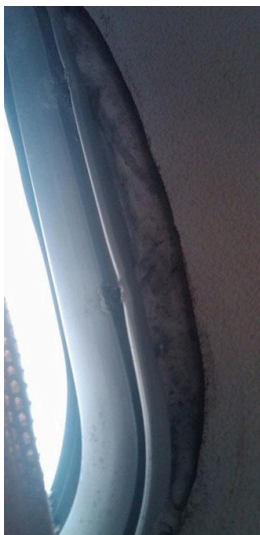
Somewhere along the way someone decided to "fix" the leak by filling the space between the port, coach roof, and liner with a very hard adhesive in hopes of stopping the leak.... This had to be dug out before removing the port... I was not able to remove all of the goop so I was forced (frustrated and resorted) to push the port out from the inside... This caused it own set of problems, cracking of the gelcoat at the corners.

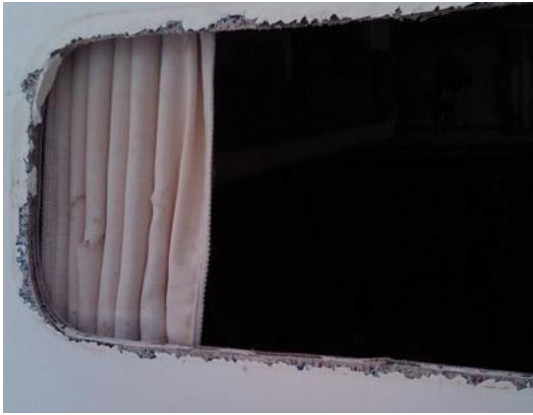
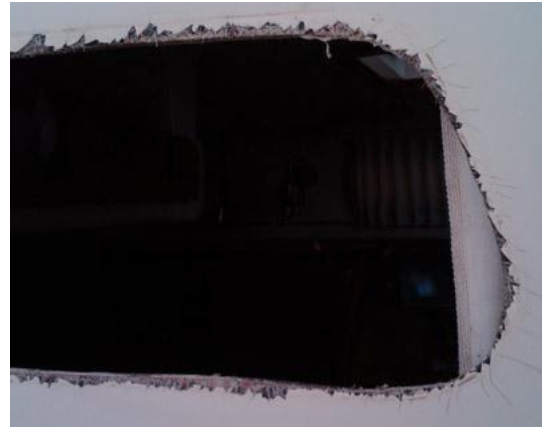
The first step was to remove the ports.... Once again a previo attempted to stop the leak by re-bedding the ports with - yes hour of carefully working with a razor blade and sturdy putty I able to remove the port. Once again the process removed muc gecoat.

Worst than that, as I pushed from the inside I was able to crac at the corner. See the "hair line" cracks in the picture below. I now get to learn how to repair gelcoat cracks.

I will provide an update on the gelcoat repair once complet

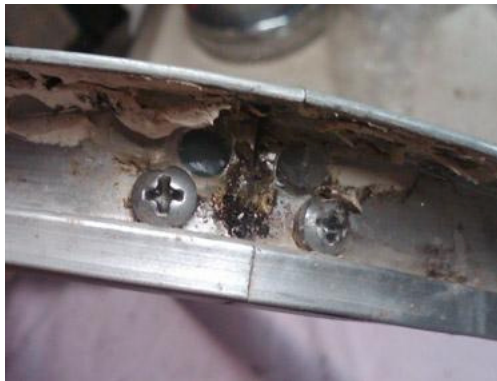
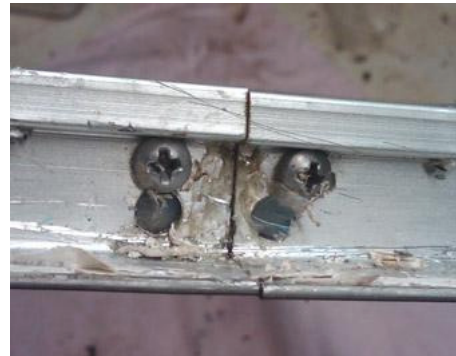
Disassembly begins with the removal of the trim gasket. This gasket is cosmetic ONLY. Fills the channel inside...

The fixed port is held together by four screws (2 on each side). The screws pass through the aluminum frame into an aluminum "backing plate". Once the screws have been removed the frame can be split into two (2) pieces and the glass and gasket removed.

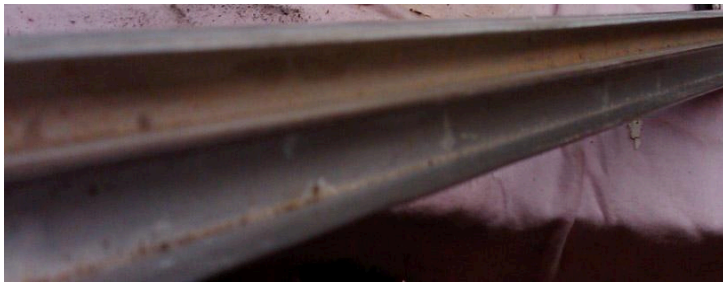
In this picture you can see the two channels. Once disassembled it is easy to see that water has been coming in around the window for some time. The corrosion can be seen clearly in the window channel (top).

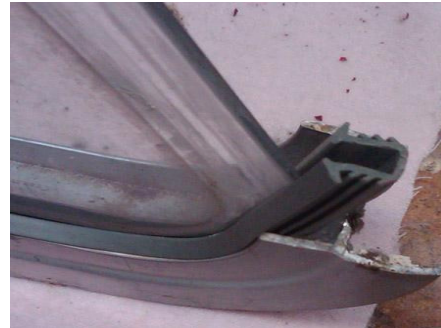
The instruction provide with the gasket reads as follows, "*Once you have cleaned and dried glass & frame, have a helper put a bead of the silicone sealant along the inside of the flexible PVC glazing channel. Have your helper hold the glazing channel. Set the glass into the glazing channel (gasket). After setting the glass into the glazing channel, have a helper put a bead of the silicone sealant along the inside of the window gap (frame). Have your helper hold the frame and set the glass with glazing channel already around it into the frame.*"

When installing t
made sure the li
the channel with

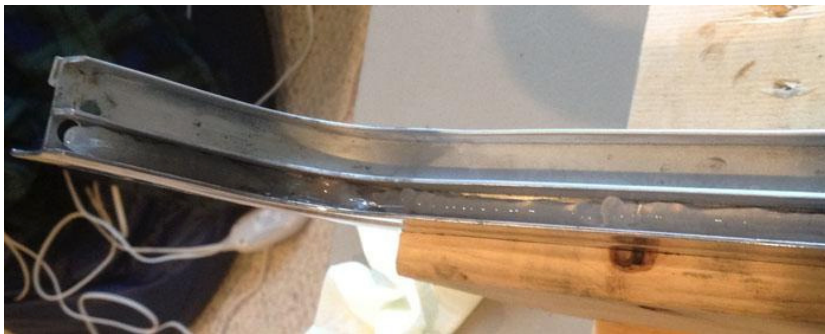
Before assembling the ports, I cleaned the channel really well water then, using a scrap piece of wood and 220 grit sand pap the channel to remove any corrosion and rough the area to all silicone to seal better.

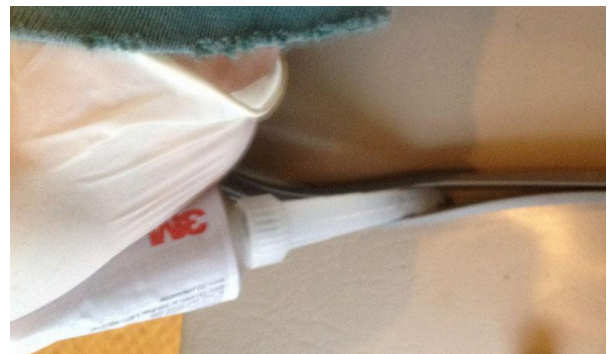
Using my simple to build jig to hold the frame in place, I applied liberal amounts of silicone to the channel.

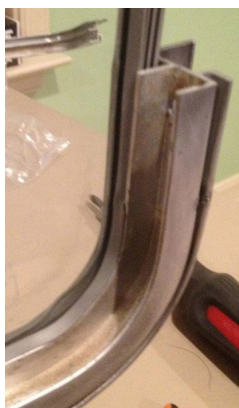
The next step required a little more joggling, I placed the glas gasket then installed the gasket into the frame. Once in the g gasket was in the track, I carefully went around the edge of tt a tooth pick and made sure the "lip" of the gasket was outside (see picture above and left).

While I had the ports out and apart, I decided to polish the aluminum frames (OK I was looking for something to do).

UPDATE: Once reinstalled, two (2) of the four (4) fixed ports continued to leak - both of the aft ports to be exact..... **Bummer!!!!** The ports are now easily remove and disassembled. As it turns out the failure was in the same location on both ports -- the lower aft corner between the glass & rubber gasket in the sharp radius formed by the forward slant. I removed the glass, cleaned it, and applied a much larger bead of silicone in the gasket, taking care to make sure the sharp corners were given extra attention (translate extra silicone).

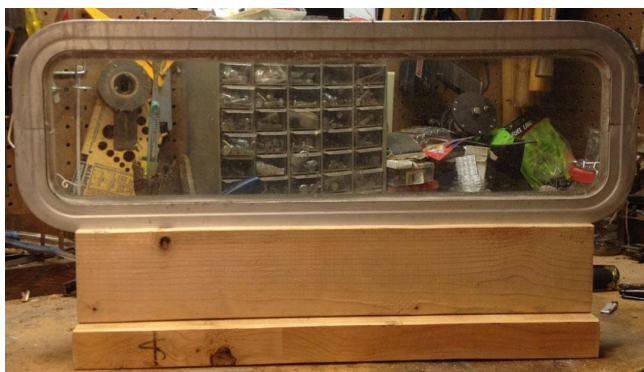
The Before and.....

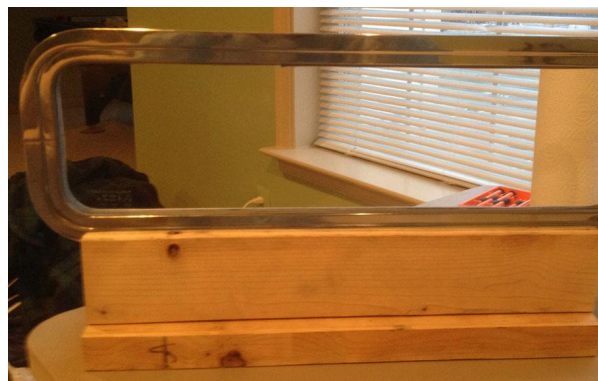
.....after can be seen below
