Rebedding the Hatches

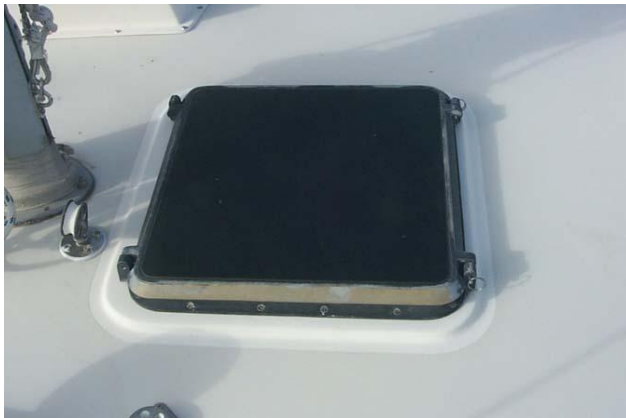
I have decided to remove and rebed the hatches and stanchions (one more time)

First step is to remove the hatches. This is a slow a tedious task.

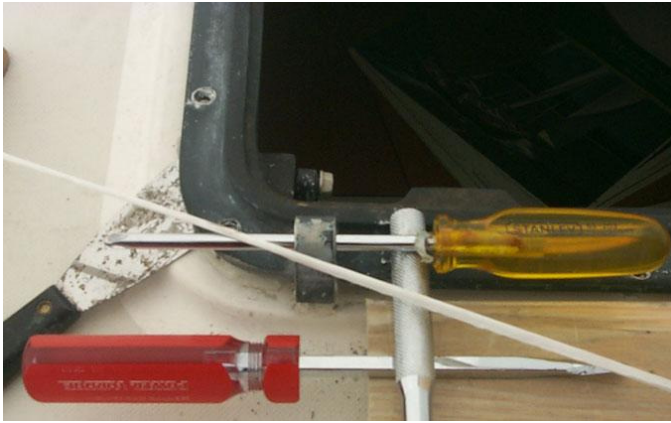
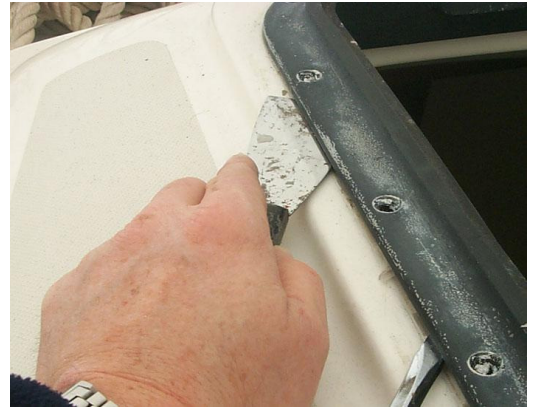
Once the hatches were removed I saw for the first time an interesting feature of our boat. Pearson installed wood only on the four sides of the hatch opening between the deck and liner. This left the corners with nothing for the screw to bite into. I will be installing larger screws when putting the hatches back on Sea Dragon.

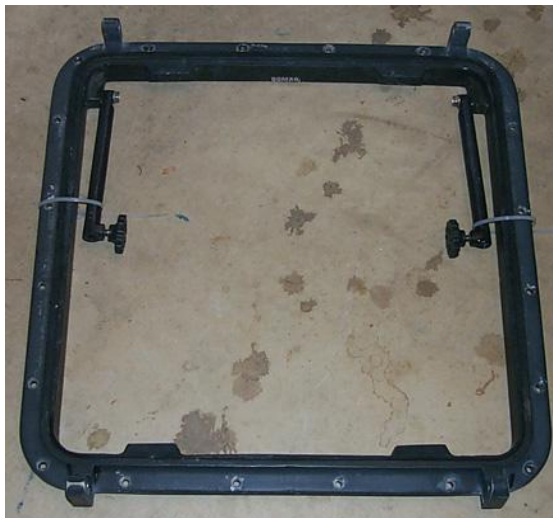
Once the hatch was out, I spent several hours cleaning all of the silicone off of the hatch frames.

Here I used a putty knife and wire brush chucked into a power drill.

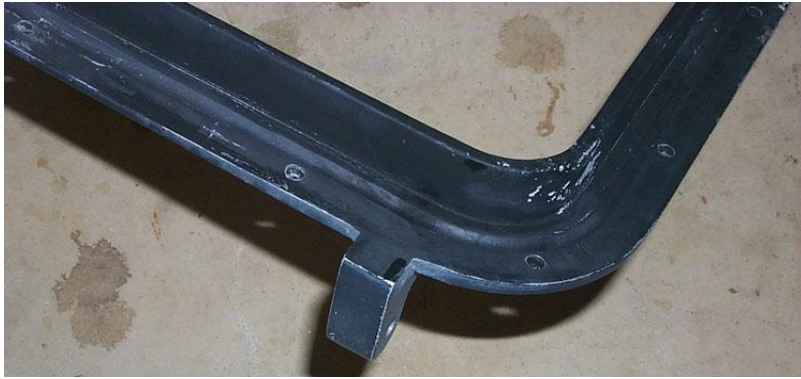
Look mom no silicone.....

I know..... I should have repainted the frames while I had them out of the boat....

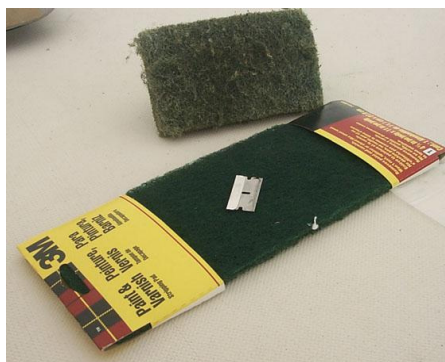
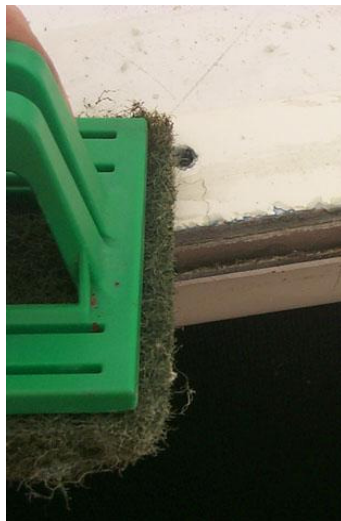
Deck clean up was slow and labor intensive but required few tools.

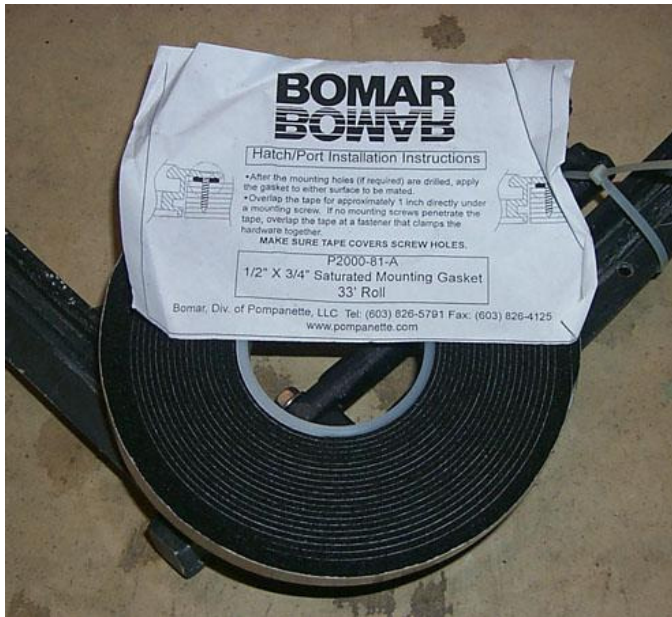
The tape is mushy material that has an adhesive on one side. The adhesive side also has a nylon string mesh, I assume for strength.

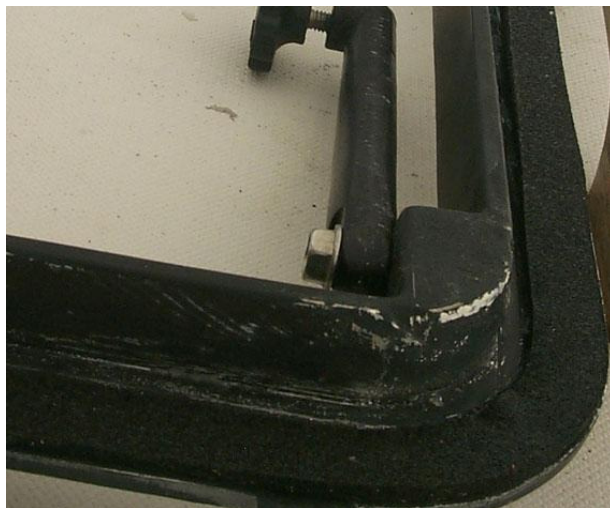
The tape was surprisingly easy to apply. It is a little messy, but strong and easily molded to the hatch frame. Radiuses were no problem.

Next the hatch was set in place and all of the screws aligned with their holes. I simply pushed the screws through tape.

I then worked around the hatch always tightening one screw then moving to the screw on the far side along the diagonal.

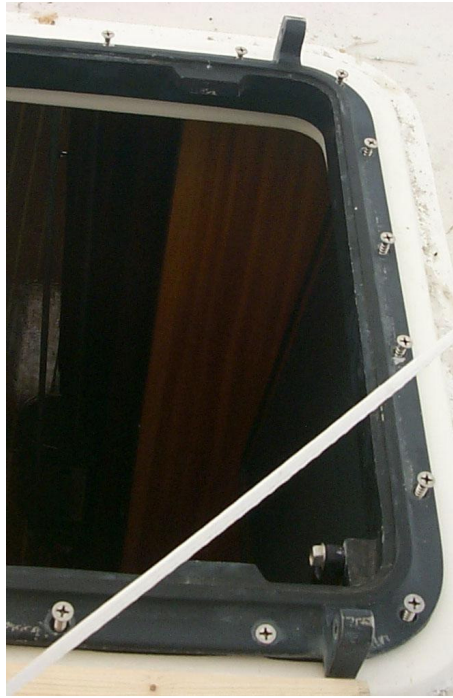
Then working around the hatch in circle to ensure that the hatch is pull into place evenly.

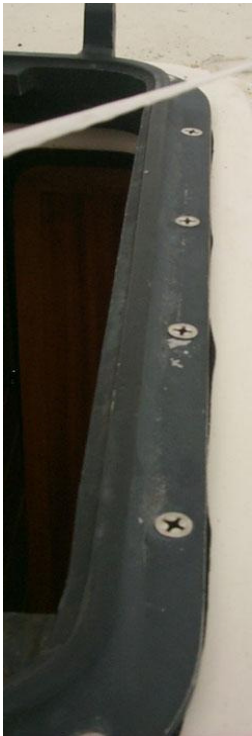
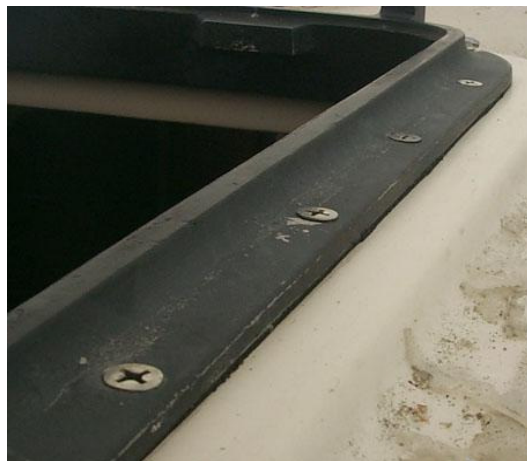
This process was repeated until all of the hatch screws were tight enough to force the tape out from between the hatch and deck.

Once again, out came my trusty razor blade and trimmed the excess tape to produce a nice clean finish.
