# Replacing the Deck Hand Rails

After almost 25 years the deck hand rails on Sea Dragon have been sanded so many times there is little left of them. While considered replacing the teak hand rails with stainless steel, I really like the look of teak.

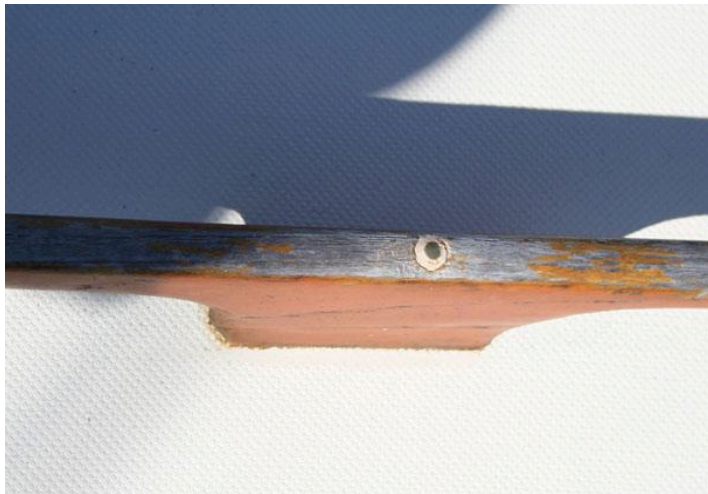
As you can see the hand rails on Sea Dragon have been sanded and finished one time too many. Yes that is the bolt showing sticking out of the top of the rail.

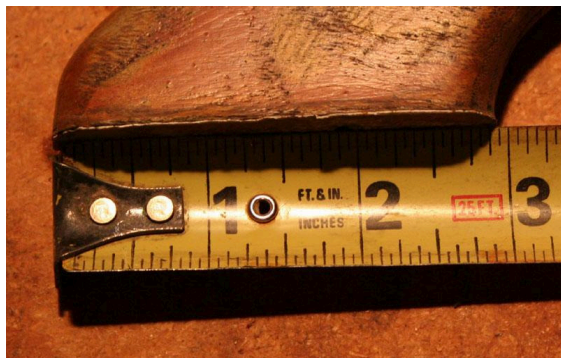
**Aft end of both Rails 3"**

In addition to have an odd dimension for the distance between loops the ends are different length.

The aft end is shorter at 3" and the forward end is 3.5".

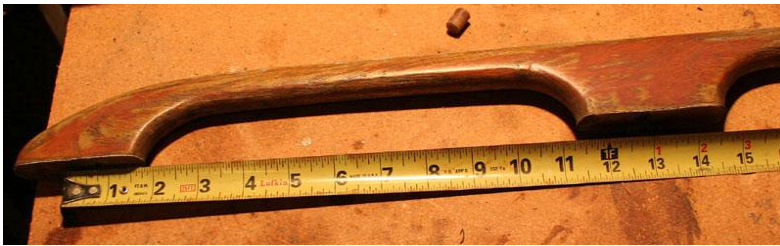
The loops on the *Sea Dragon* are on 13" centers.

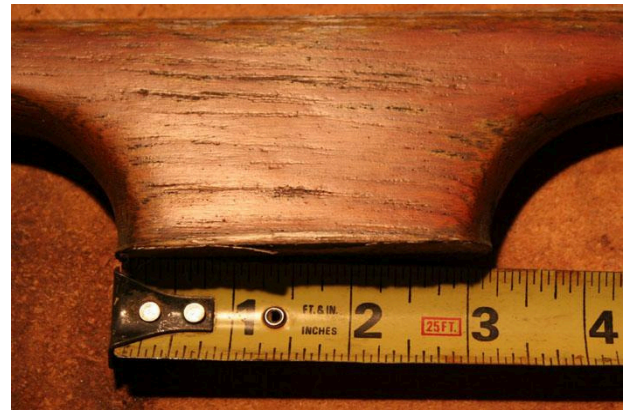
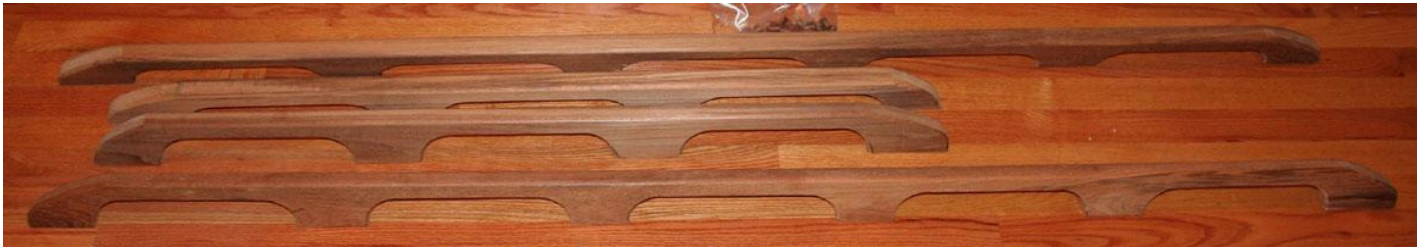
Above you can see the new hand rails.. Note the rails are NOT flat on the bottom but cut at an angle to match the slope of the coach roof so that they sit vertically.

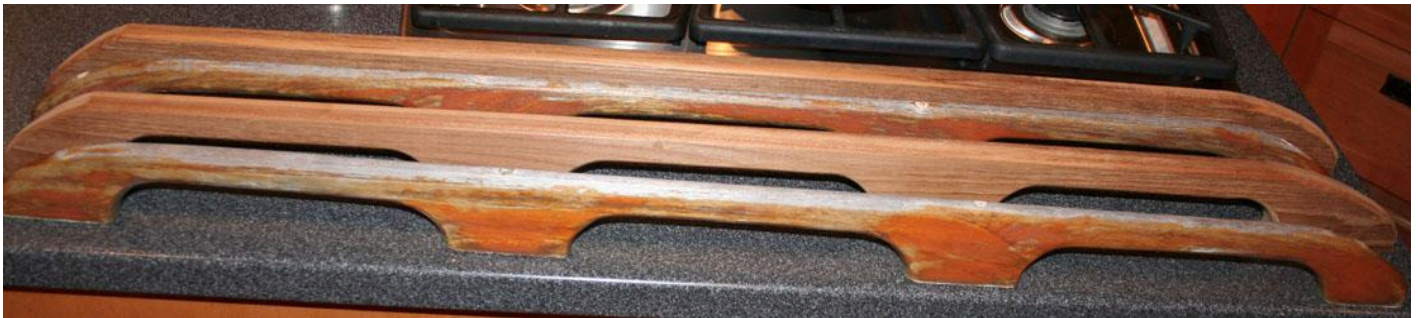
Below you can see the new hand rails next to the old rails.

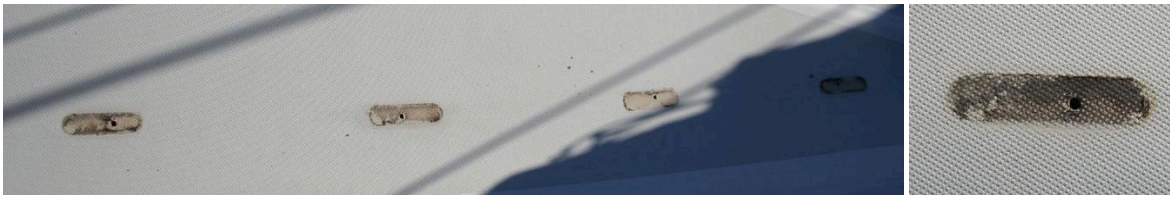
Once removed I noticed that differences in each of the contact points. Some were clean, while other clearly had a lot of dirt under them... This leads me to believe that the only way dirt can get under the rails is if water is running under them carrying dirt. This may be the source of my mystery leak I have been chasing for three years... Keep your fingers crossed.

After removing the rails I cleaned the area well and filled the holes with silicone sealant while I drill and finish the rails over the next few weeks...

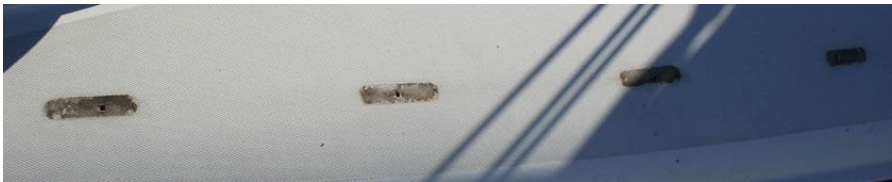
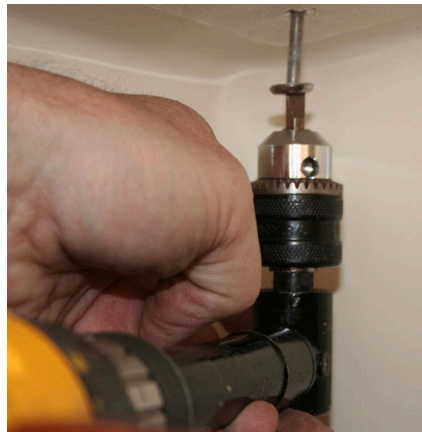
One of the starboard aft rail's screw is in the dish rack and not easily reached. Using my hand-dandy \$4.99 [Harbor Freight](#) right angle attachment I was able to quickly and easily remove the last screw.

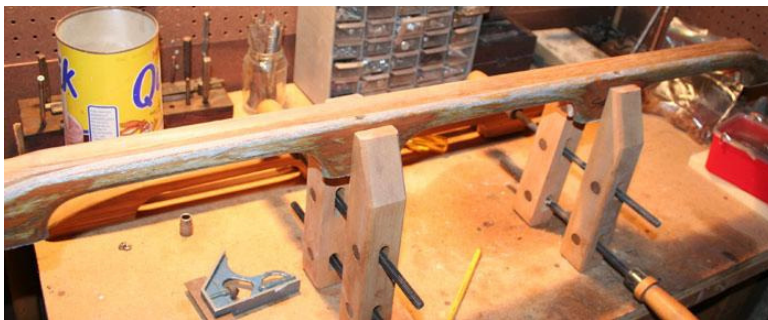
The first step was to clamp and align the original rail and the new rail so I could mark each hole to be drilled.

Using a square I marked each hole. Then I found the center of the rail.

Next the rails are clamped onto the drill press and using a 3/8" (1/8" drill bit) countersink to make the hole.

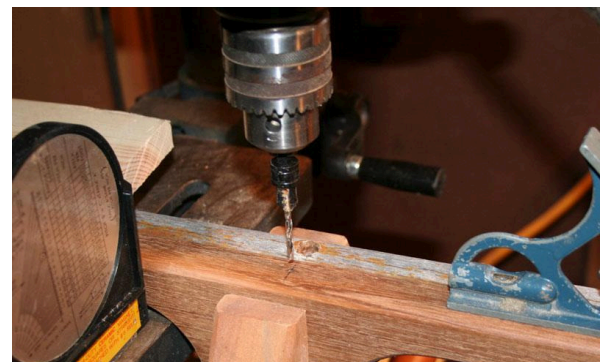
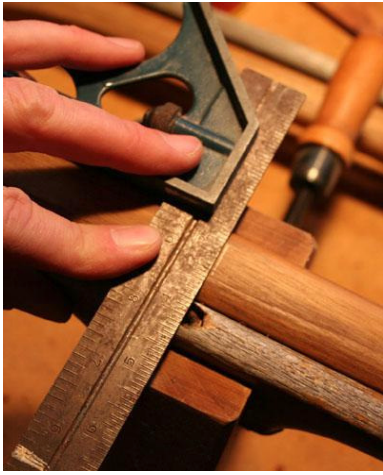
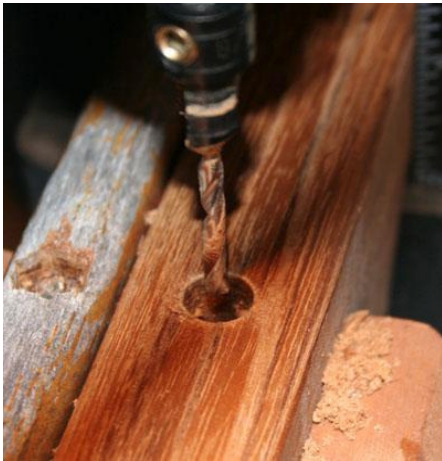
The bit was not long enough to drill all the way through the rail so a longer bit is chucked in and the hole is complete.

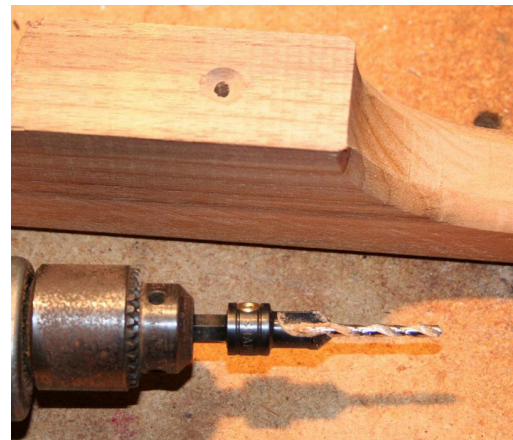
In order to improve the seal I countersink each hole so that I will be able to create an O-ring like seal.

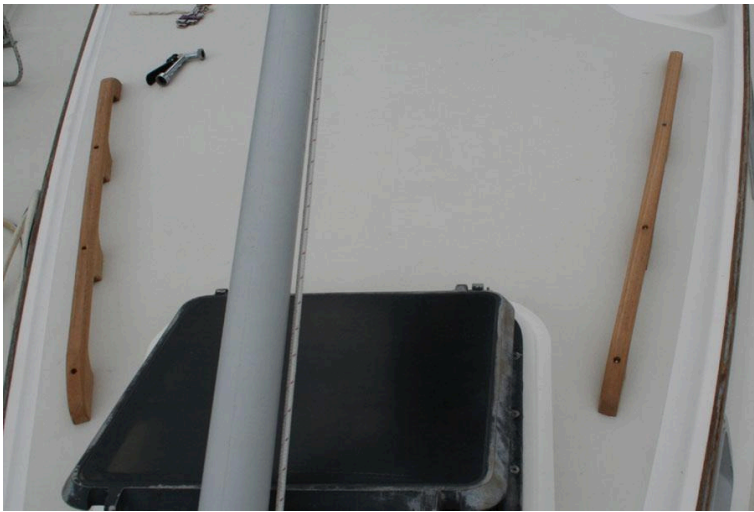
After several months of procrastinating, I finally installed the hand rails. With the first handrail I learned a very tough lesson. I had taken such care to drill the new handrails at 90 degrees only to learn that the original holes were anything but 90 degrees. It appears that the factory installed the handrails by drilling both the coach roof and handrails at the same time and only "eye-balling" the location and angles.

So I took them home and did the best I could to match the angles of the old handrails. This made it possible to finally align the holes and bolts & dry fit the rails.

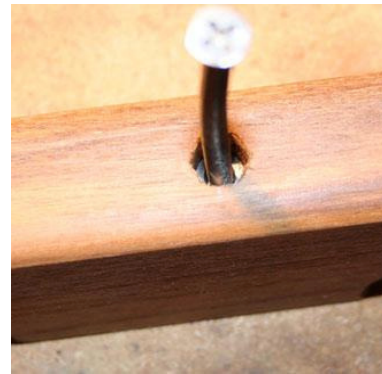
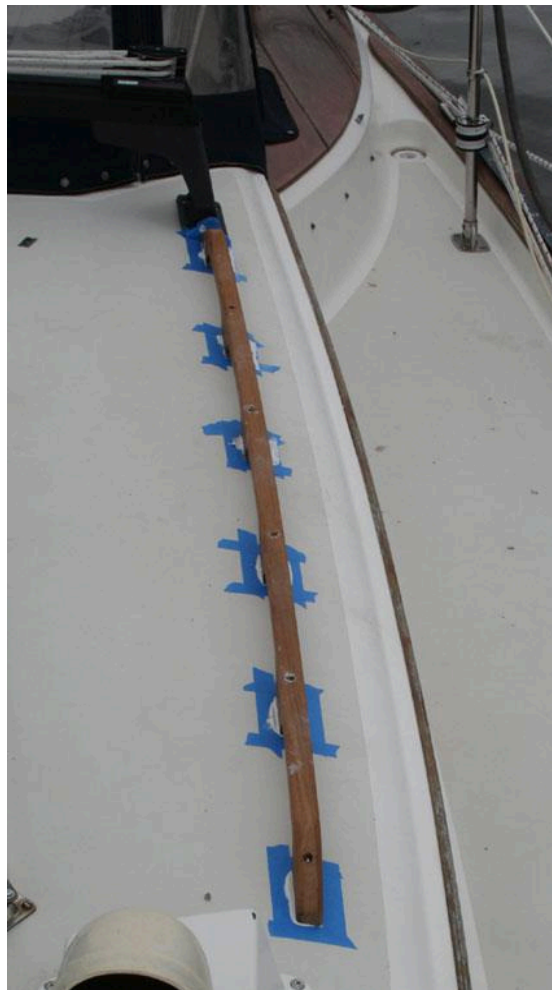
After dry fitting the rails I cleaned the holes very, very well and inserted the nuts. Another lesson learned is that the smallest amount of wood will jam the threads of the screw & bolt. Each of the bolts and nuts on *Sea dragon* are 10 x 32 and anywhere from 2.5" to almost 6" in length. To set the nuts in the handrails, I simply placed the nut on spare screw and tapped it into place with a small hammer.

Next each rail is tapped off and large amounts of **Boatlife Life Seal** are added to the bottom of the rails and deck. Then with the help of a fellow Pearson owner the handrails are installed. I left the **Life Seal** undisturbed for 24 hours before removing the tape and excess **Life Seal**. Once it has cured for a 10 to 14 days I will re-tighten the handrails and install the plugs.
